# **SERVICE BULLETIN**

APPLICABILITY: 2014-22MY Forester NUMBER: 05-88-21

**SUBJECT:** Front Stabilizer Bushing- Design Change

Knocking / Squeaking Sound

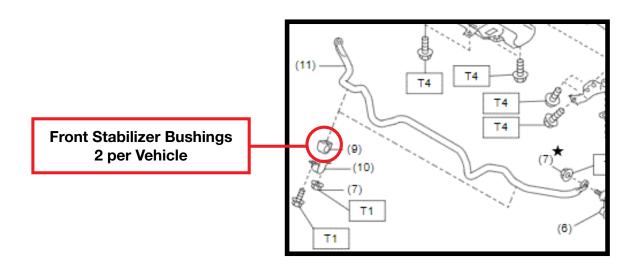
This bulletin announces a design change made to the front stabilizer bushings. The bushing material has been enhanced to address knocking / squeaking sounds when driving on rough roads during low ambient temperatures. If confirmed under the described driving conditions, the bushings shown in the illustration below should be replaced.

The service procedures for front stabilizer bushing replacement remain unchanged. Always refer to the applicable Service Manual and review the full requirements of the repair being performed. The Service Manual procedures contain information critical to performing an effective repair the first time, every time. This includes but is not limited to important SAFETY precautions, proper inspection criteria, necessary special tools, required processes and related one-time-use parts needed for a complete and lasting repair.

Refer to the applicable Subaru Service Manual: <u>Suspension > FRONT SUSPENSION > Stabilizer > STABILIZER BUSHING</u>
