TECHNICAL SERVICE BULLETIN

Intermittent Power Sliding Door Operation - With or Without DTC U201A

22-2305

Ford 2019-2022 Transit

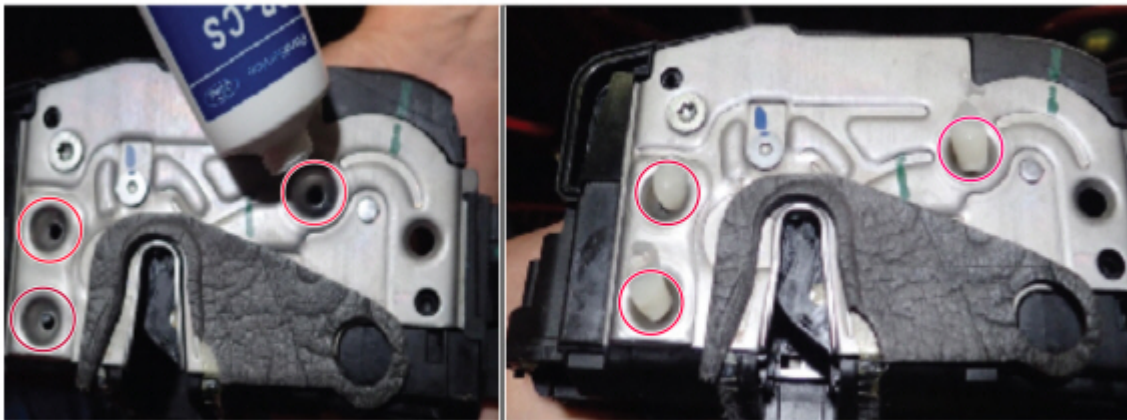
Figure 1

(2). Apply Motorcraft® silicone brake caliper grease and dielectric compound or equivalent to the latch at the fastener/washer locations (x3). (Figure 1)

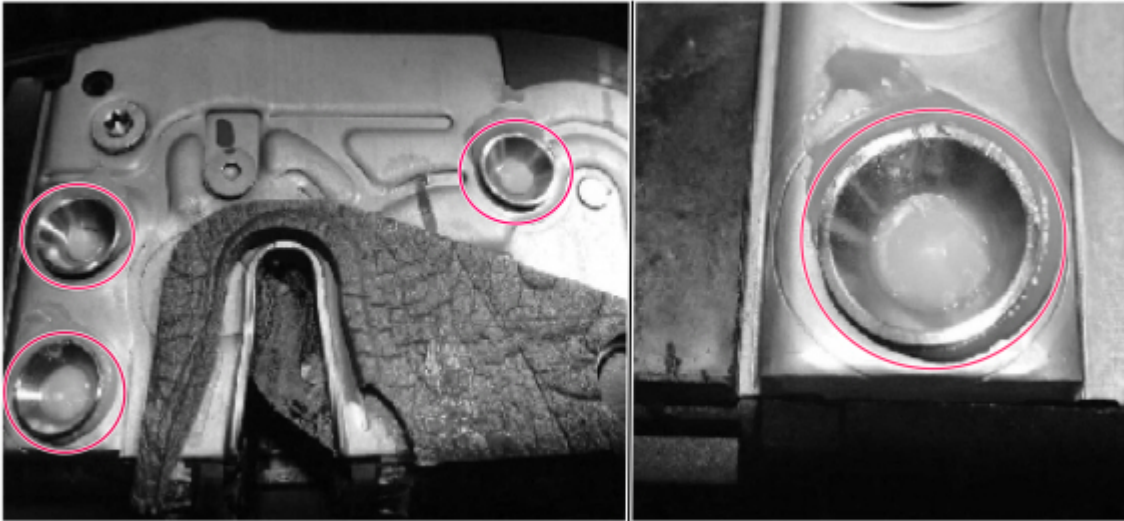
Figure 2

(3). Add 1 conical washer at each location where grease was applied. (Figure 2)

NOTE: 3 conical washers must be added to the sliding door latch prior to installation.

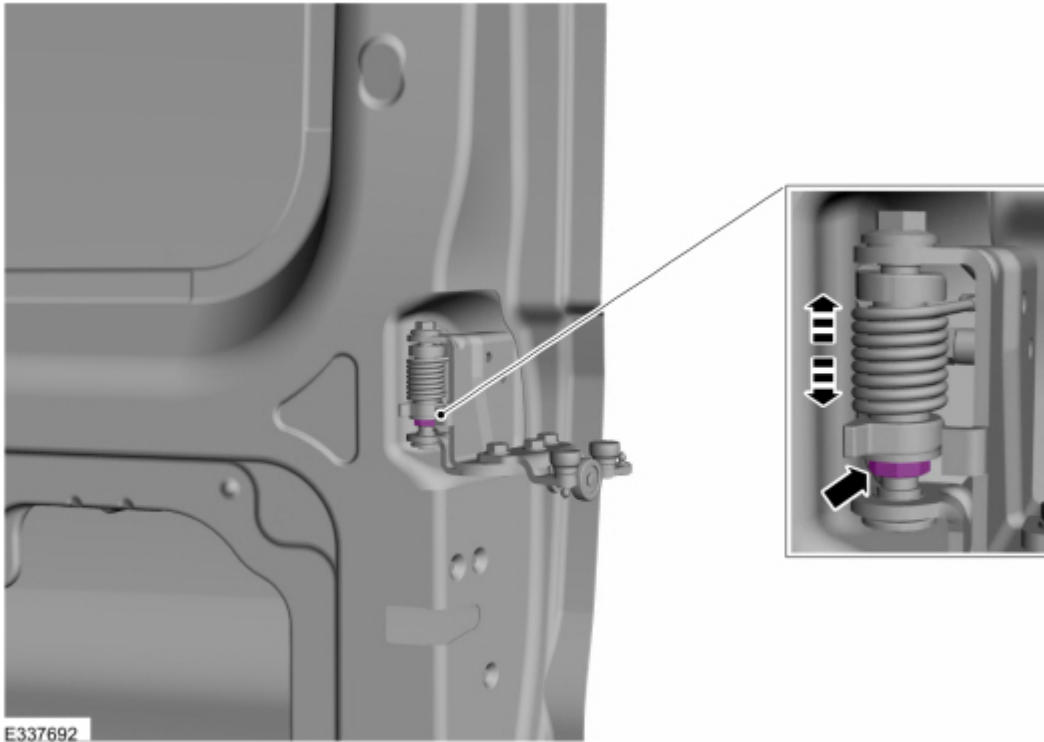
Figure 4

- To adjust the sliding door downwards, rotate the adjustment bolt counterclockwise 1 full turn, 1 mm (0.039in). (Figure 4)

(5). Adjust the sliding door center roller downwards. Refer to WSM, Section 501-03 Body Closures > General Procedures > Sliding Door Alignment > Steps 16-17-18.

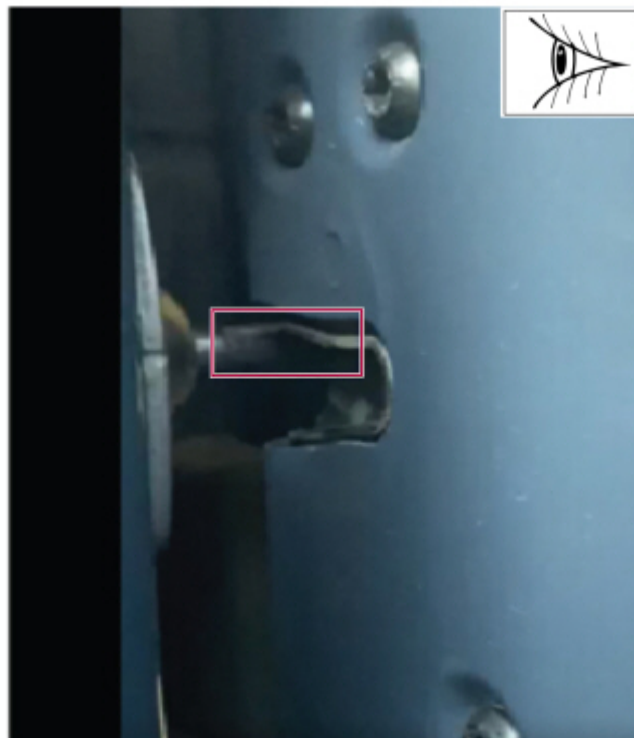
Figure 5

NOTE: Once the sliding door center roller is adjusted, the striker should be off-centered biased towards the upper area of the latch (before latching) with zero interference to the latch. (Figure 5)
