TECHNICAL SERVICE BULLETIN

3.0L Diesel - Low Oil Pressure At Idle

22-2386
17 October 2022

Ford 2018-2021 F-150	Engine: 3.0L diesel
--------------------------------	---------------------

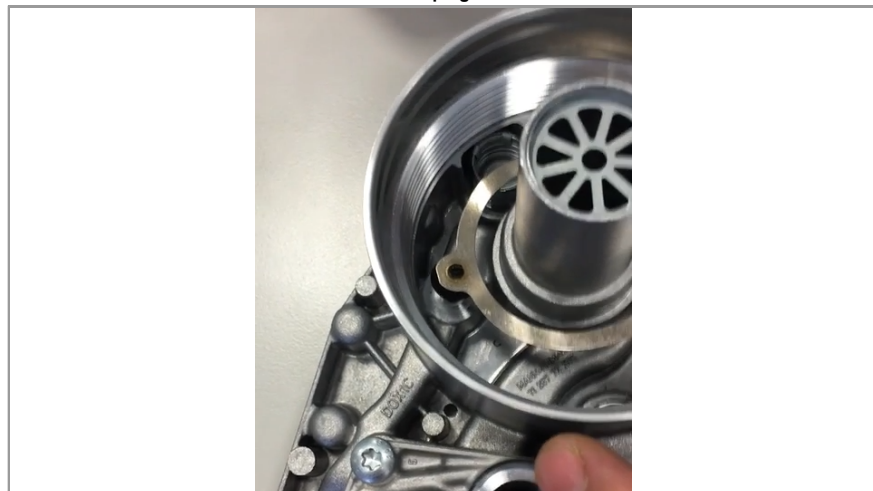
Issue: Some 2018-2021 F-150 vehicles equipped with the 3.0L diesel engine may experience low oil pressure at idle after an oil change. This condition may be caused by a broken anti-drain back oil plug in the oil filter adapter. The anti-drain back oil plug is now available to be serviced separately from the oil filter adapter. To correct this condition, follow this service procedure to replace the anti-drain back oil plug.

Removal and installation of the anti-drain back oil plug

1. Remove the oil filter cap and the oil filter.
2. Inspect the inside bottom of the oil filter adapter for a broken anti-drain back oil plug. Is the plug damaged?
 - (1). Yes - proceed to Step 3.
 - (2). No - this article does not apply. Proceed to Step 4 and continue with diagnostics. Refer to WSM, Section 303-00 Engine System > General Information, Diagnosis and Testing.
3. Remove and discard the damaged anti-drain back oil plug and replace it with a new anti-drain back oil plug.

4. Reinstall the oil filter and oil filter cap.
5. Check the oil level at normal engine operating temperature. Is the oil level at the proper level?
 - (1). Yes - repair is complete.
 - (2). No - add engine oil until the proper engine oil level is achieved.
