SERVICE BULLETIN

APPLICABILITY: 2013MY Legacy and Outback
 with a Backup Camera

NUMBER: 15-156-12R

SUBJECT: Deletion of Compass Mirror

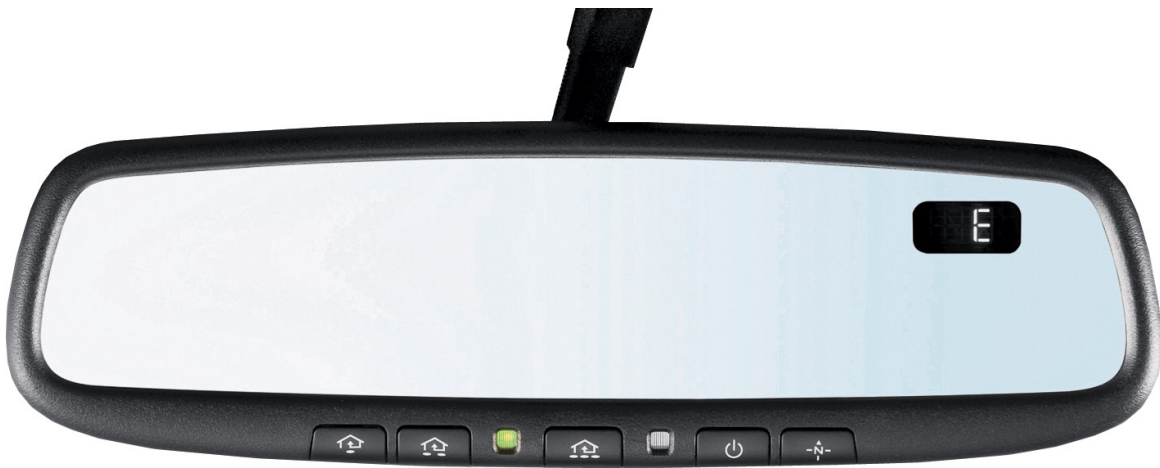
Auto-Dimming Compass Mirror with HomeLink

For mirror installation, remove the OE mirror by first disconnecting the wire harness from the back of the mirror. Loosen the Torx® screw then slide the mirror upward and off of the windshield mirror mount.

Install the replacement mirror by sliding it down onto the windshield mirror mount. Then tighten the Torx screw to 13.3 – 17.7 in-lbs., and re-connect the wire harness to the back of the mirror.
