## SERVICE BULLETIN

**APPLICABILITY:** 2017-22MY Impreza  
2018-22MY Crosstrek

**NUMBER:** 12-247-23

**SUBJECT:** Rear Gate Stay / Design Change

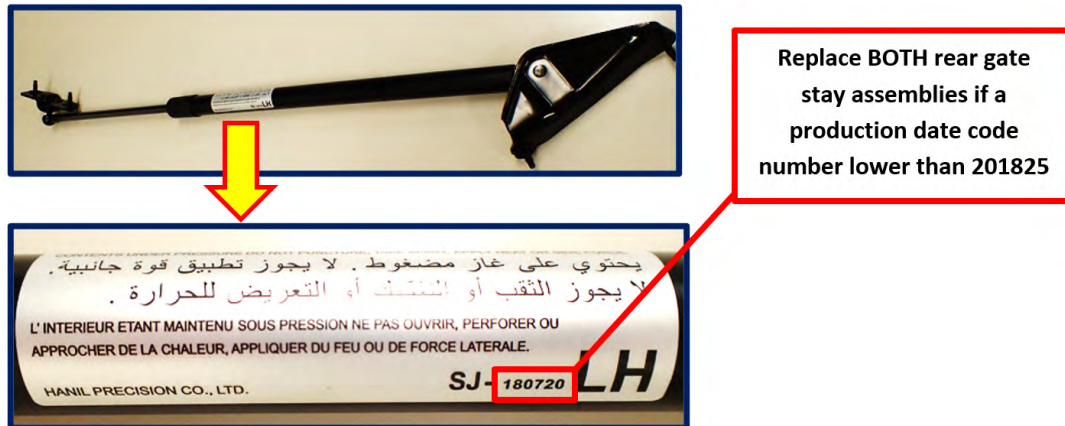
It is important to identify the production date code of the rear gate stay assemblies to verify if new parts have or have not been installed on to the vehicle. If the new parts are already installed, confirm fault sources such as mechanical resistance, gate alignment, physical damage etc. are not the cause before proceeding with rear gate stay replacements.

The service procedures for the rear gate stay assemblies remain unchanged. Always refer to the applicable Service Manual and review the full requirements of the repair being performed. The Service Manual procedures contain information critical to performing an effective repair the first time, every time. This includes but is not limited to important SAFETY precautions, proper inspection criteria, necessary special tools, required processes and related one-time-use parts needed for a complete and lasting repair.
