SERVICE BULLETIN

APPLICABILITY: All Models with 1.8, 2.0, 2.2 and 2.5L “EJ” Engines **NUMBER:** 02-142-13
SUBJECT: Oil Seepage from Automatic Timing Belt Tension Adjuster **DATE:** 08/09/13

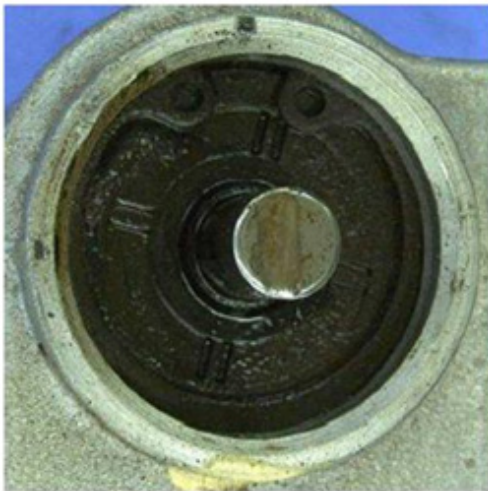
Normal

No Oil past the rod seal other than a slight amount of residual seepage.

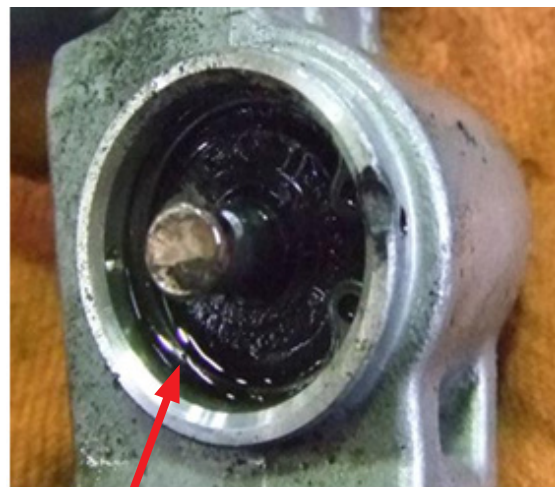
Failed

Significant accumulation of oil which has leaked past the rod seal.

These tension adjusters must always be compressed SLOWLY and with the rod in a vertical position. Compressing them too quickly (too much force applied) or horizontally may result in weakening or damage to the tensioner.
