SERVICE BULLETIN

APPLICABILITY: 2015-2017MY WRX 2.0L DIT Models

NUMBER: 03-78-17

SUBJECT: Clutch Release Bearing- Design Change

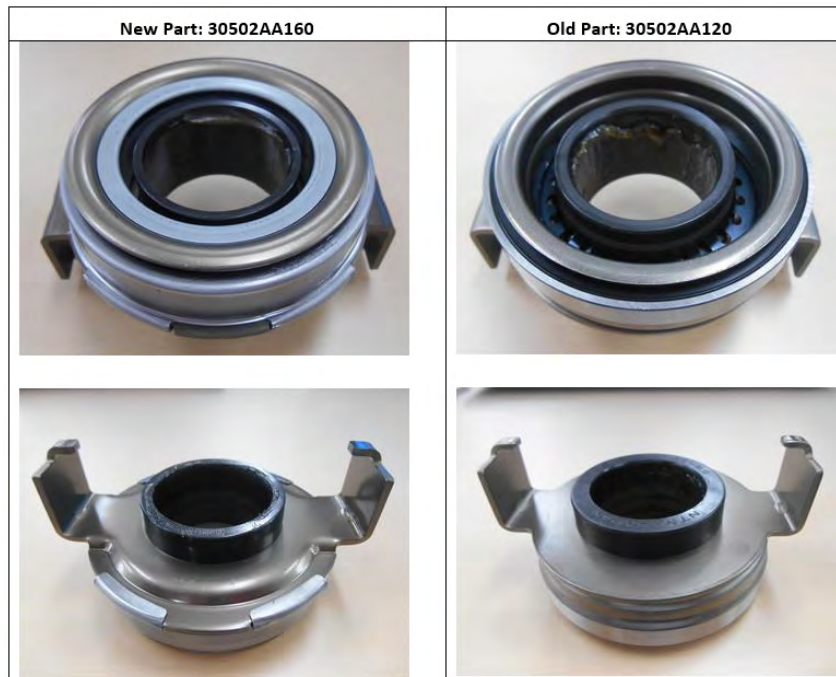
The part number for the new clutch release bearing is: **30502AA160**. The photos below show the differences between the old and new-style parts. The shape of the outer race has been changed.

This bulletin announces a design change to the clutch release bearing. The change will address customer concerns of a chirping-type sound which may be heard following initial start-up after a cold soak. The sound normally dissipates after 2-3 minutes of operation.

The new clutch release bearing was incorporated into production starting with VIN **H9824973**.

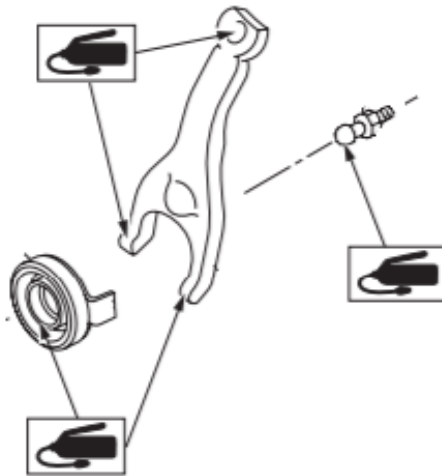
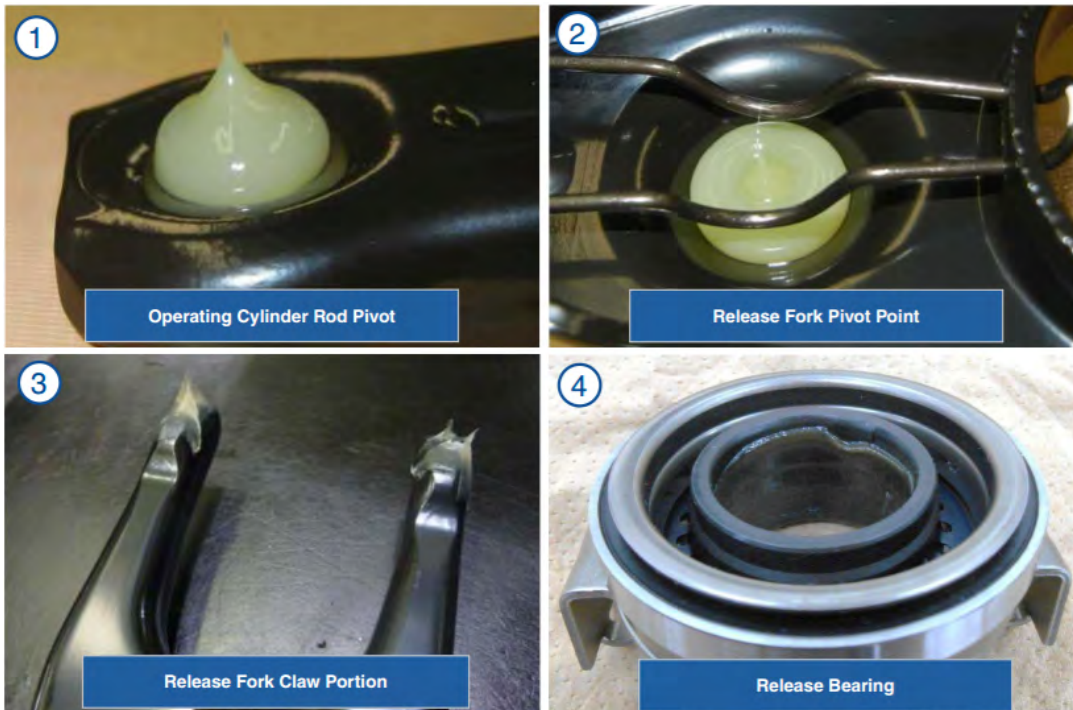
- Always inspect for any excessive or abnormal wear on the release fork pivot point, operating cylinder rod and release lever pivot points, and the pivot ball.
- Always use the proper grease (Nichimoly N-130, Conoco-Philips Multiplex Red #2 or Subaru p.n. 000041000) when lubricating the contact points of the release bearing and related components as specified in the Service Manual and shown below.
