SERVICE BULLETIN

APPLICABILITY: 2019-22MY Ascent

NUMBER: 07-219-23R

SUBJECT: Genuine Alternative Battery Replacement

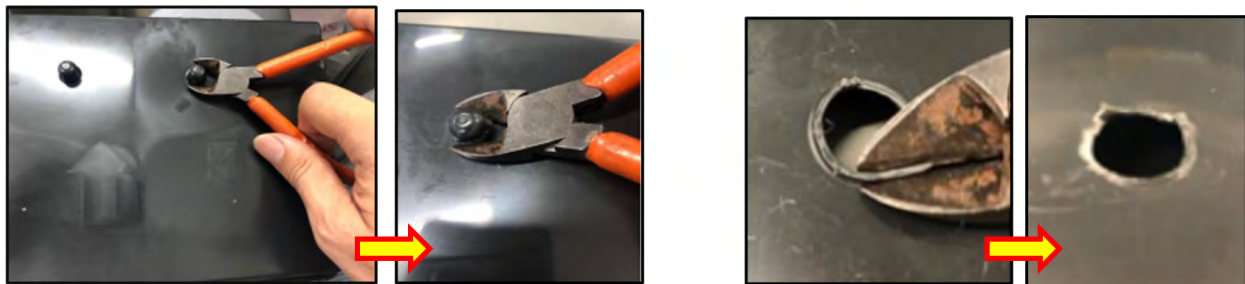
- A. **CAREFULLY** cut off and trim the two protrusions on the bottom of the battery tray. This will allow a more streamlined fit when installed on the vehicle. Try to make the cut as flush as possible.

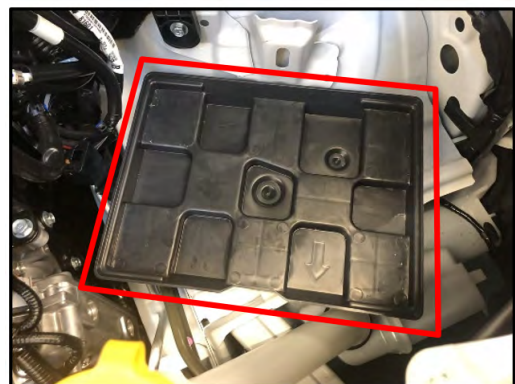
- B. Remove the original battery tray. **DO NOT** discard, this must be returned to the customer.

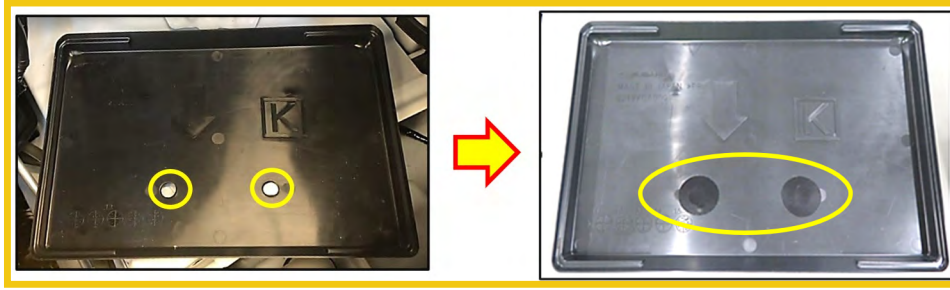
C. Cover the newly made holes with the grommet sheets (p.n. 909230046).

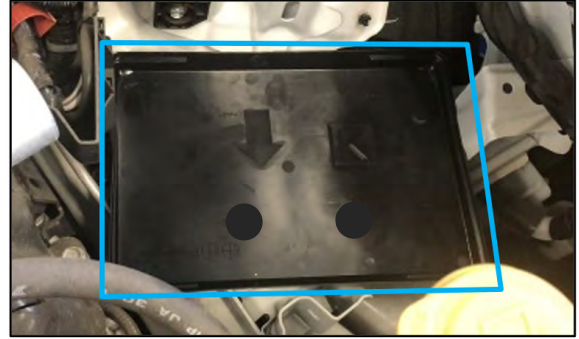
D. Securely fit the replacement battery tray to the vehicle.

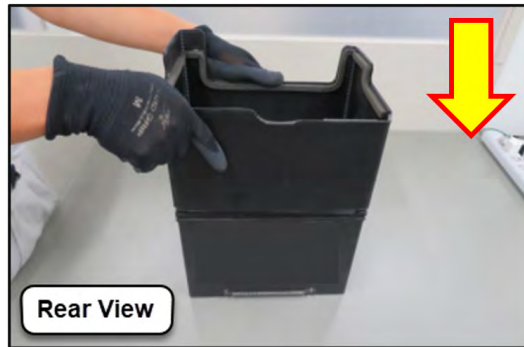
STEP 4: Install the replacement battery cover (p.n. 82123AN000) to the alternative replacement battery. Confirm the bottom of the cover is aligned flush with the bottom of the battery. **DO NOT** discard, this must be returned to the customer.

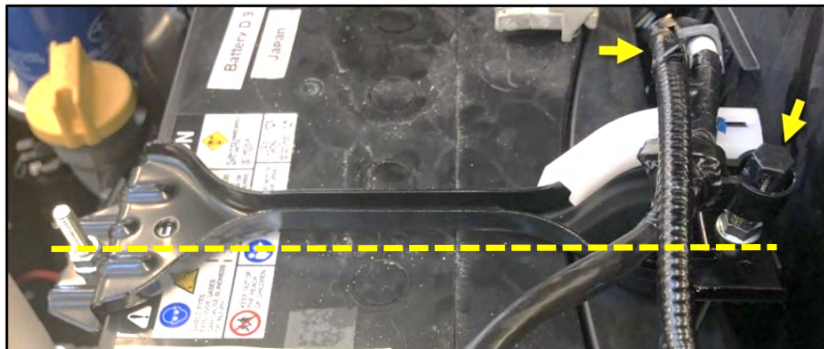
STEP 7: Install the battery holder and holding rods on to the battery.

- A. Torque the two holding rod mounting nuts to **3.5 N·m (2.6ft.-lbs. or 31inch.-lbs.)**.
- B. Torque the positive terminal to **6 N·m (4.4ft.-lbs. or 53inch.-lbs.)**.
- C. Torque the negative terminal to **7.5Nm (5.5ft.-lbs. or 66inch.-lbs.)**.
- D. If the battery sensor is removed or disconnected torque to 7.5Nm (5.5ft.-lbs. or 66inch.-lbs.) while supporting the sensor with the other hand as outlined in the applicable Service Manual under: STARTING/CHARGING SYSTSEMS > Battery Sensor.

NOTE: Confirm the battery holder is center mounted with the battery cables secured and routed correctly.
