SERVICE BULLETIN

Classification: EM02-003	Reference: NTB02-050	Date: April 23, 2002
-----------------------------	-------------------------	-------------------------

VQ ENGINE WATER PUMP O-RING

APPLIED VEHICLES: 2002 Pathfinder (R50)
2002 Maxima (A33)
2002 Altima (L31)

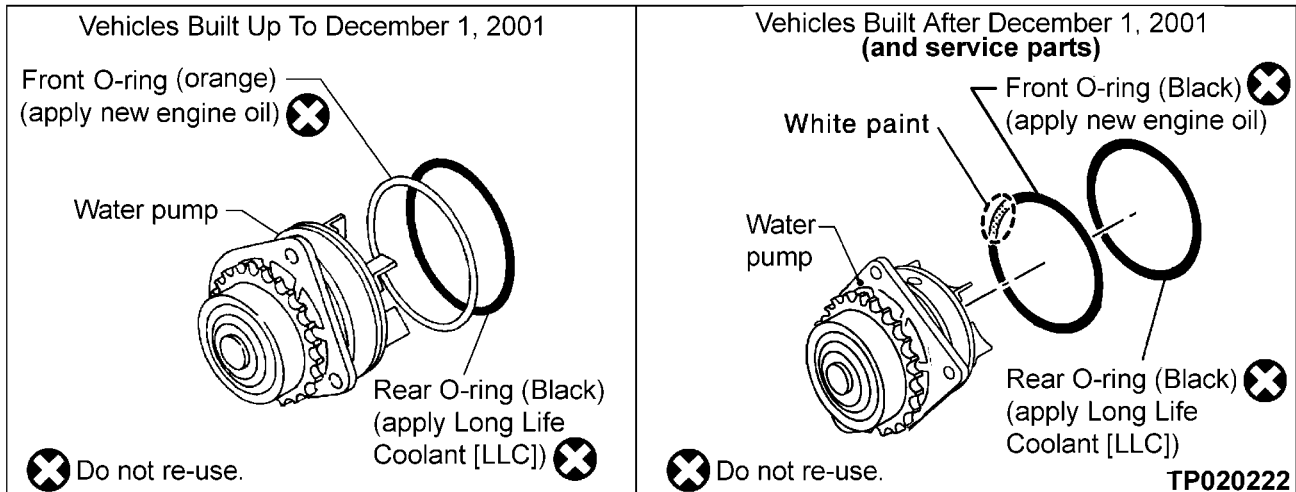
Figure 1

- The front O-ring (on the water pump) has changed
- The new O-ring is now black with a white paint mark instead of orange in color (see Figure 1)

If, for any reason, the water pump needs to be serviced, please note that:
