WORK DESCRIPTION FOR FIELD MEASURE

Code: 1612P82D52 **Version: 2.0**

Replace additional brake lamp

Model 217 and 205

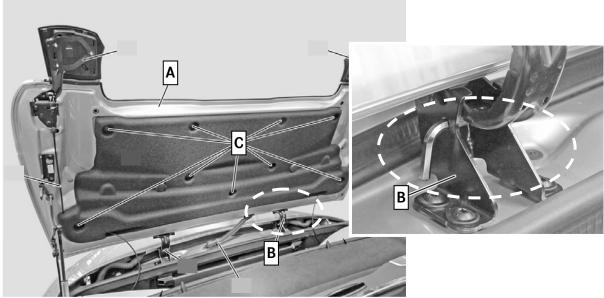
Figure 1

1. Open soft top and move soft top compartment cover (A, figure 1) into the vertical position.

Secure soft top compartment cover (A, figure 1) through the holes in the hinges (B, figure 1) against closing using appropriate tools.

2. Only on model 217 Remove soft top compartment cover paneling (C, figure 1).

1 To do so, remove retaining clips (C, figure 1).

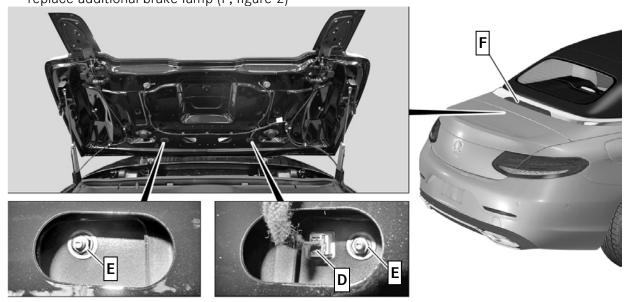
Figure 2

3. Disconnect connector (D, figure 2), remove nuts (E, figure 2) and replace additional brake lamp (F, figure 2)
