GROUP <b>Body</b>	MODEL <b>2011-2013 Optima (TF &amp; QF) 2011-2015MY Sorento (XMa)</b>
	NUMBER <b>PS235 (Rev 1, 06/25/2014)</b>	DATE <b>January 2013</b>

**SUBJECT:**      **HORN ANSWER BACK OR PARKING LAMPS INOP  
WHEN LOCKING DOORS WITH RKE/SMK FOB**

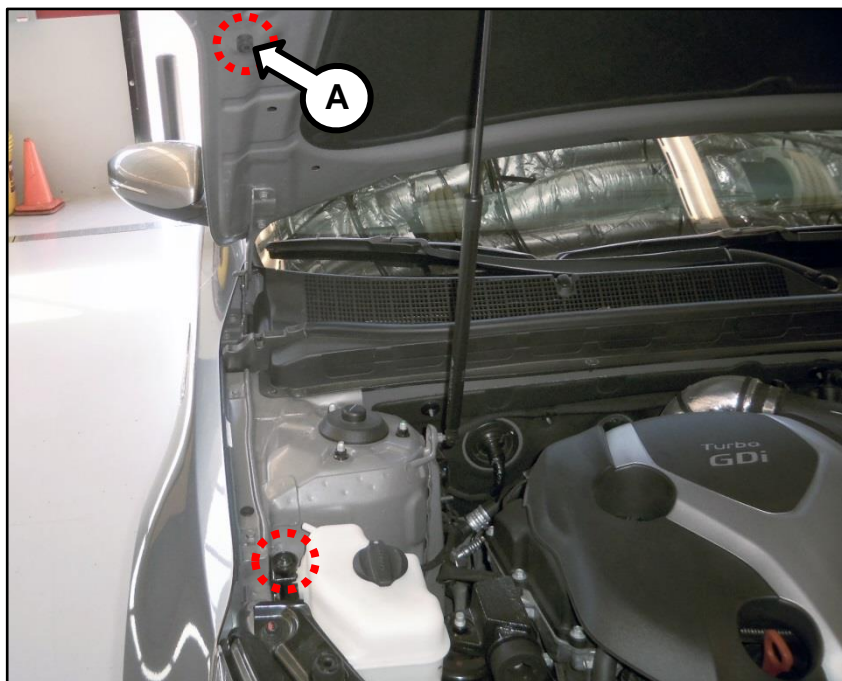
- Check to make sure the pad-lid switch (hood switch depressor) is in place on the hood (A).

When addressing a customer complaint related to an inoperative parking light confirmation flash, and/or audible answer back when locking the vehicle with the RKE/SMK fob, ensure each door lock position switch (viewable in **BCM > Current Data**) is displaying the appropriate status and the pad-lid switch (hood switch depressor) is in place on the hood. Refer to the photo and screenshot below for additional information.

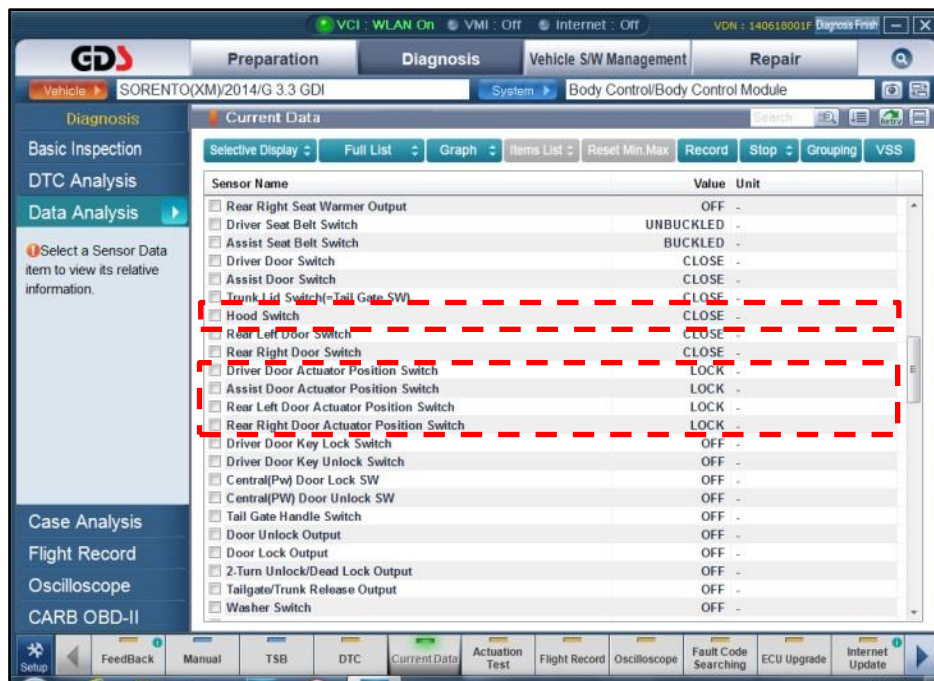
- Use GDS to Access **BCM > Current Data** and check for the status of the **Hood Switch** and **Door Actuator Position Switches**.
