Service Bulletin

Bulletin No.: PIP5247

Subject: P06DE Low Oil Pressure Piston Oil Nozzle Squirter Parts Found In Oil Pan

Models: 2013-2014 Cadillac ATS
 2014 Cadillac CTS
 2013-2014 Chevrolet Impala
 2013-2014 Chevrolet Malibu
 2014 Buick Regal
 equipped with 2.0L or 2.5L (RPO codes LTG, LCV or LKW)

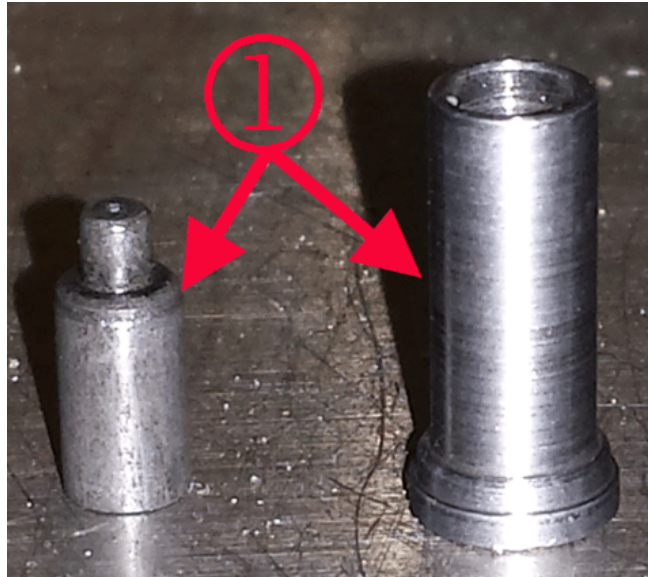
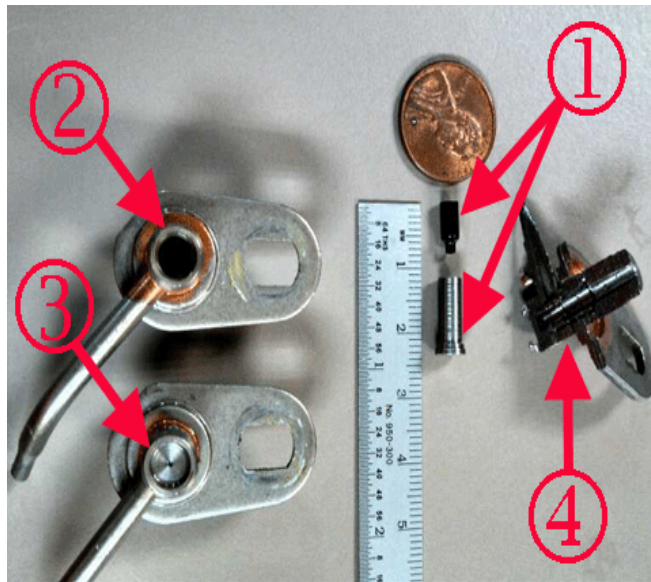
4041662

If diagnostics lead to removing the oil pan or engine oil pressure is below specification when hot, inspect the oil piston nozzles / squirters for damage.

If the objects match the pictures below, they are internal components from a broken piston oil nozzle / squirter.

1. Internal parts of a piston oil nozzle / squirter
2. Damaged piston oil nozzle / squirter where internal parts came from
3. Undamaged piston oil nozzle / squirter
4. Cross section view of a piston oil nozzle / squirter

Replace the broken oil nozzle(s) / squirter(s) as long as the engine does not have any damage which warrants engine replacement.
