Service Bulletin

Bulletin No.: PIT5300

Subject: Normal Characteristic - No Remote Detected / Place Key in Transmitter Pocket / Press Brake To Restart DIC Messages

Models: 2015 Cadillac Escalade Models
2015 Chevrolet Suburban, Tahoe
2015 GMC Yukon Models
With Keyless Start (RPO BTM)

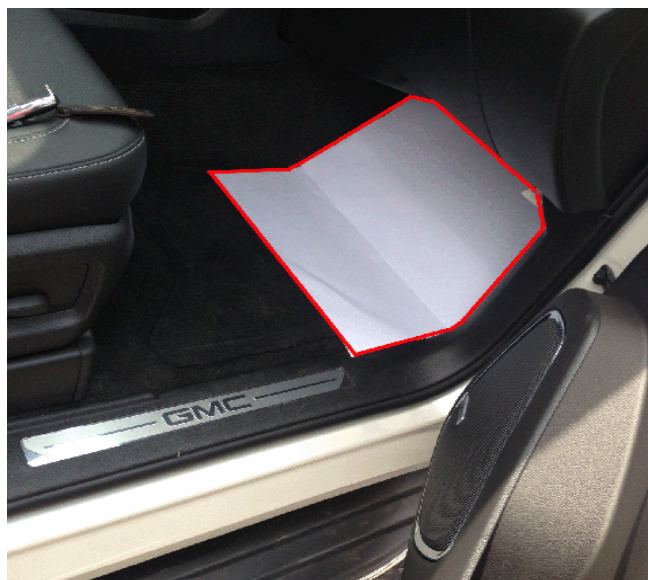
- If a key fob button is being pressed when the engine start/stop button is pushed, the concern may happen. In most cases, a fob button can be unintentionally pressed if the fob is in the customer's pants pocket, purse, backpack, etc. Taking the fob out of his/her pants pocket, purse, backpack, etc. and retrying to start the vehicle will correct the issue.
- If the key fob is placed on the passenger front floor, in the area shown in the photo below, the concern may happen. The fob could be inside a purse, back pack, etc. but just as long as it is in the area shown when the engine start/stop button is pushed, the concern may happen. If the fob is moved out of the area shown, and the engine start/stop button is pressed, this will correct the issue.

Please communicate to the customer this condition is a normal operating characteristic of their vehicle and that the Recommendation section should be followed to prevent either condition from occurring. It will not impact the designed performance or reliability of the vehicle. Please share this information with the customer, including a copy of this message.
