51868-02139 Version 6

Warranty Extension: MIL Comes On with DTCs P0301 Thru P0304

Year	Model	Trim	VIN Range
2010–12	Crosstour	All V6	Check the iN VIN Status for Eligibility.

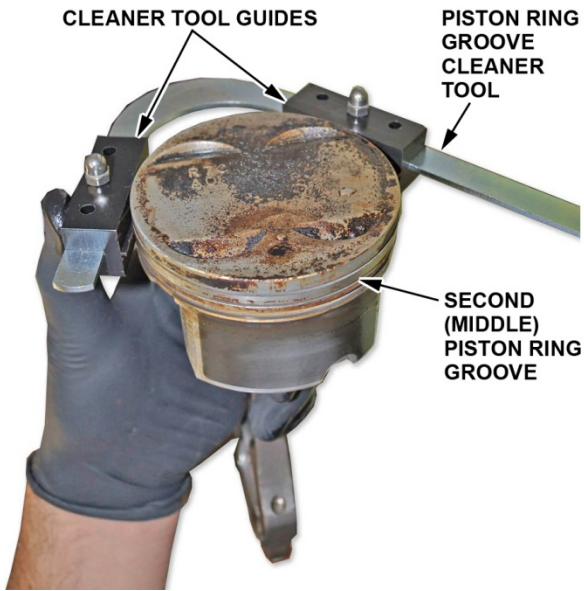
3. While holding the piston upright in your left hand, take the piston ring groove cleaner tool in your right hand and line up the cleaner tool guides with the second (middle) piston ring groove.

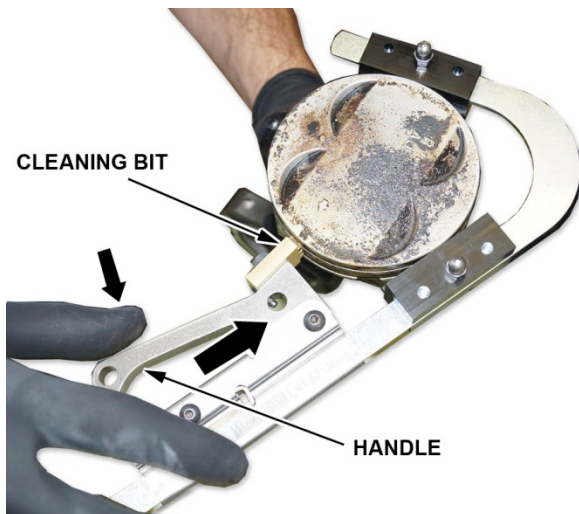
4. Press the handle on the piston ring groove cleaner tool and slide the cleaning bit onto the appropriate piston ring grooves.

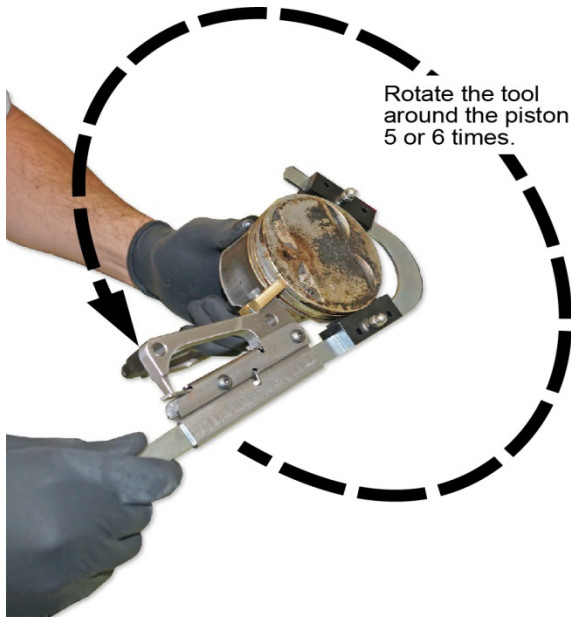
6. Hold the piston steady and rotate the tool counterclockwise five to six times to remove any carbon deposits in the piston ring grooves. **Do not** rotate the tool clockwise.

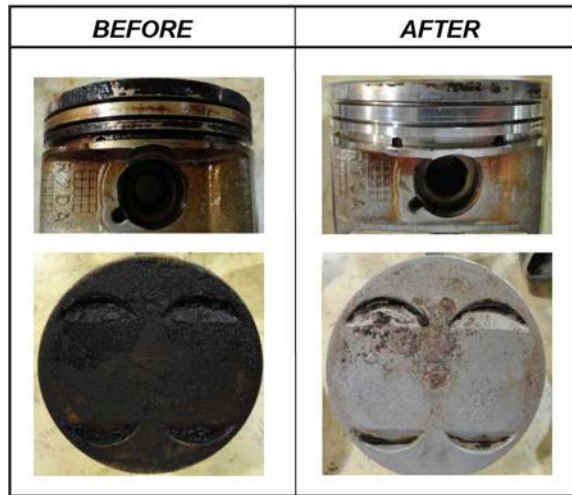
54K PISTON

NOTE: Below are some examples of before and after pictures. Depending on mileage and running conditions, the pistons will achieve different levels of cleanliness.
