51869-02164 Version 7

## Warranty Extension: MIL Comes On With DTCs P0301 thru P0304

Year	Model	Trim	VIN Range
2009–13	Pilot	ALL	Check the iN VIN Status for Eligibility

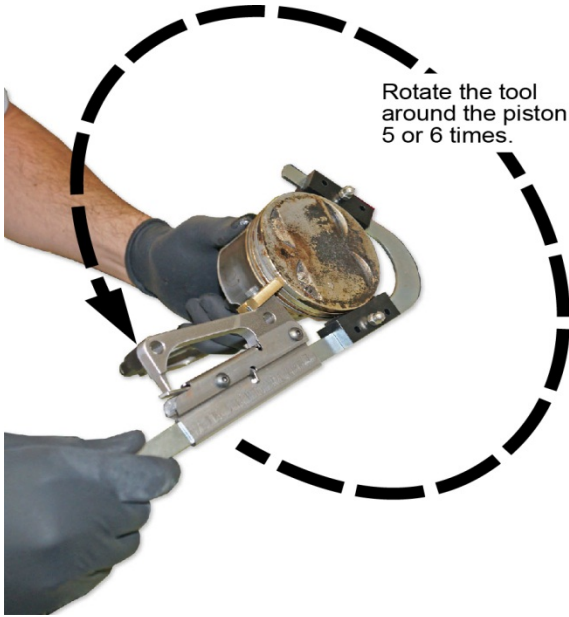
6. Hold the piston steady and rotate the tool counter-clockwise five to six times to remove any carbon deposits in the piston ring grooves. **Do not** rotate the tool clockwise.

NOTE: You can watch this procedure in the *Tech2Tech* segment "How to Clean Piston Ring Grooves".
