SERVICE BULLETIN

APPLICABILITY: 2001~07MY Legacy/Outback H-6
 2003~08MY Forester 2.5L N/A and Turbo
 2004~11MY Impreza 2.5L N/A

NUMBER: 04-13-09R

SUBJECT: Power Steering Pump Relief Valve

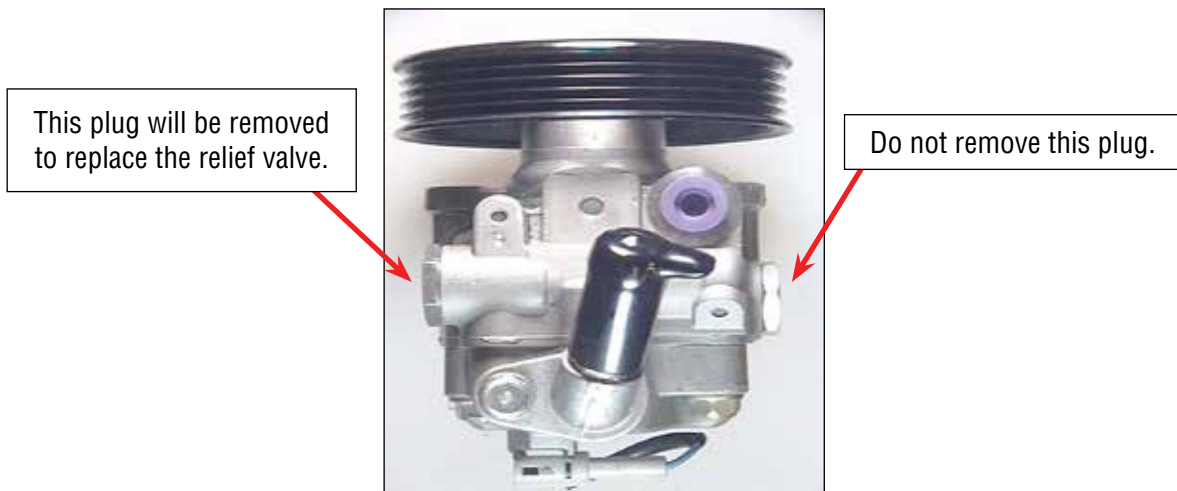
- Park the vehicle on a dry solid surface (concrete preferred). With the engine idling, transmission in park or neutral with the parking brake applied, turn the steering wheel to the full right or left position. If the noise is heard, replace the relief valve.

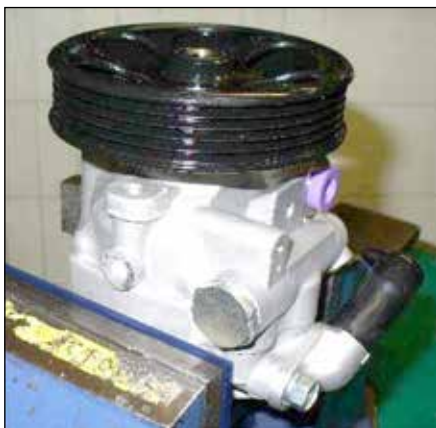
- Remove the power steering pump; refer to the applicable service manual.

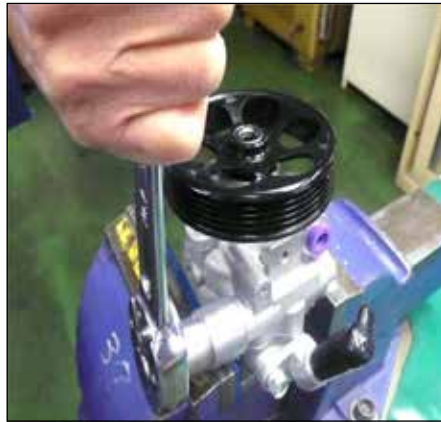
- Place the power steering pump in a vise.

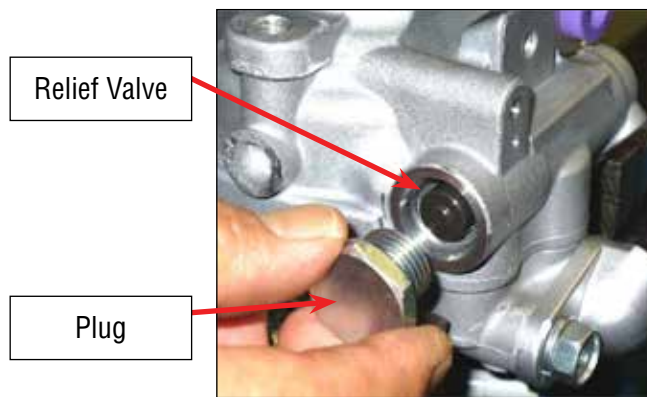
- Remove the plug using a 22mm box wrench.

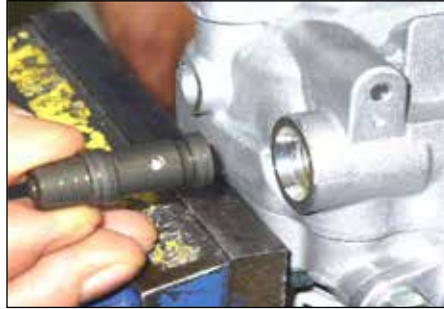
- Using a pair of tweezers, remove the relief valve. Note: Be careful not to scratch the inside of the pump housing.

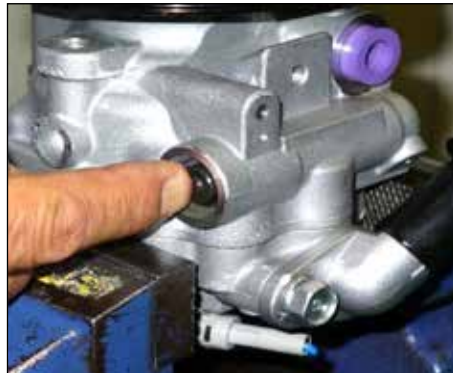
- Install a new relief valve.

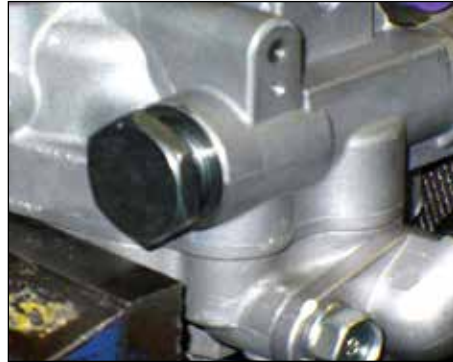
- Confirm that the relief valve moves smoothly by pushing it in and out several times.

- Install plug and torque to proper specification 30~40 N-m (3.0~4.0 Kgf-m, 22.1~29.5 ft-lb)
- Reinstall power steering pump; refer to the applicable service manual.
